# Urban Disaster Prevention Project

A feasibility study of regional disaster prevention in the Kobe Government

Commission VII, Working Group 9

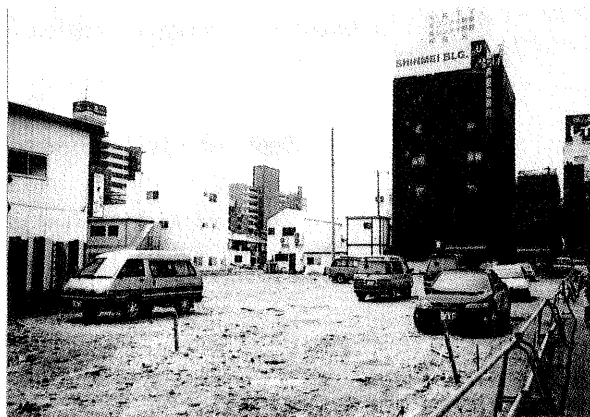
Photograph 1. Fireproof Building (Nagata District)

Buildings and houses with high fire resistance were left intact unless burned-out by fire. Although these fireproof buildings splendidly fulfilled their roles in the prevention of the spread of fire, the narrow streets turned out to be an obstacle to fire-fighting, and in addition the high residential density influenced the size of the urban fire disaster.
